STRUCTURAL REHABILITATION OF A CHLORIDE
CONTAMINATED SILO

**Structural Rehabilitation
of a Chloride-Contaminated
Concrete Silo in the Azores**

Reparação,
Consolidação
e Modificação
de Estruturas, S.A.

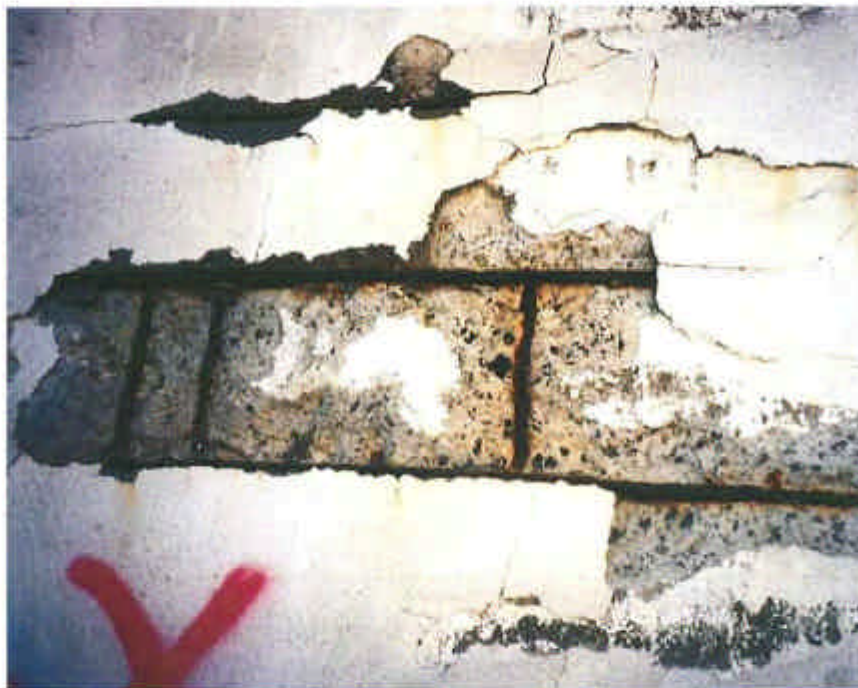
The silo was built by the slipform method, using very porous volcanic aggregates and beach sand. For already some years, signs of significant deterioration had been noticed, mainly widespread concrete spalling owing to corrosion of reinforcement (Figure 1).

Figure 1 – Area showing severe deterioration, marked for concrete removal.

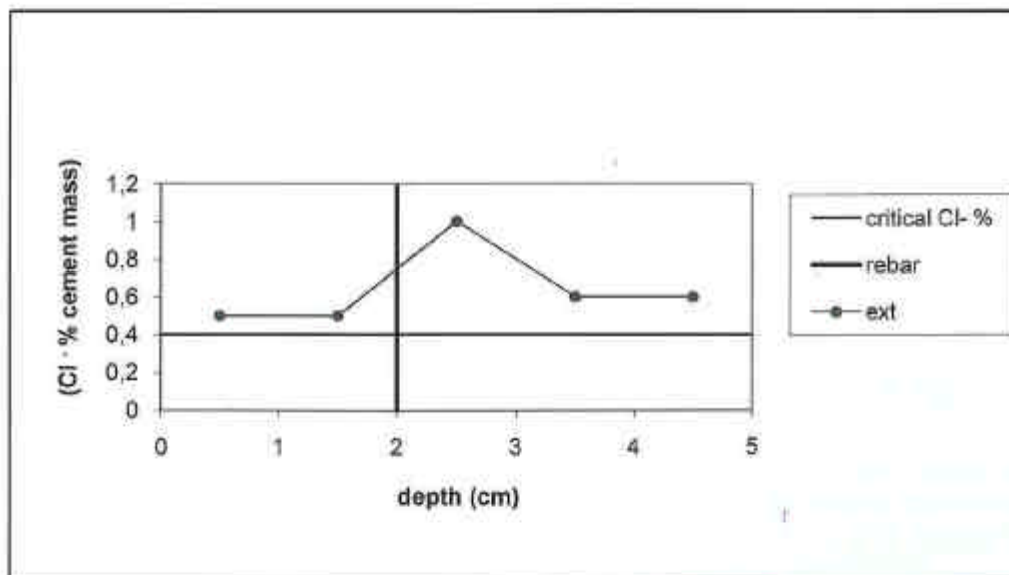
Chloride content was high, 0.6% to 1% of cement mass at reinforcement depth (Figure 2), and showed that the high chloride content obtained on the external surfaces was mainly due to the diffusion of the air-borne chlorides.

Fig. 2 – Measured chloride content near the external surface of the silo.

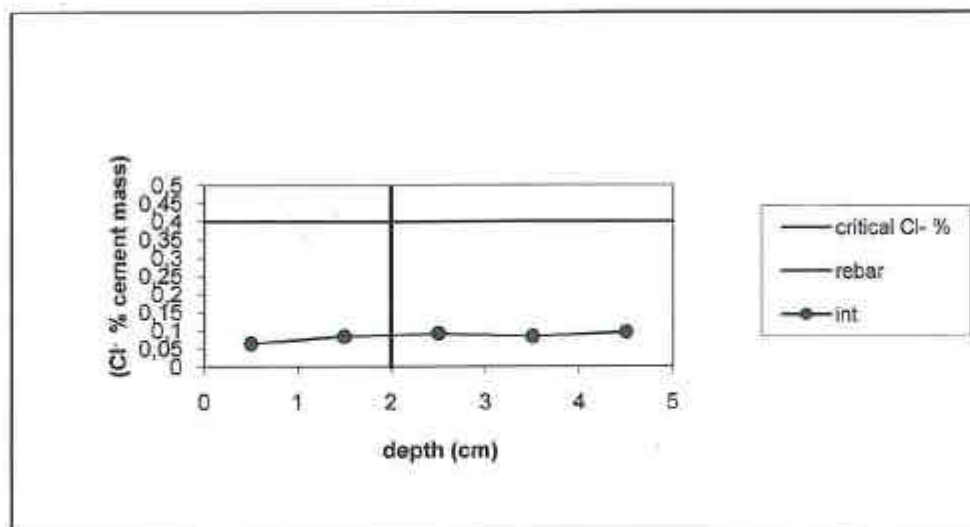
The measured chloride content at the inside surface of the silos was 0.09% of cement mass at reinforcing depth (Figure 3), lower than the outside value and lower than the critical limit value of 0.4% of the cement mass.

Fig. 3 - Measured chloride content near the internal surface of the silo.

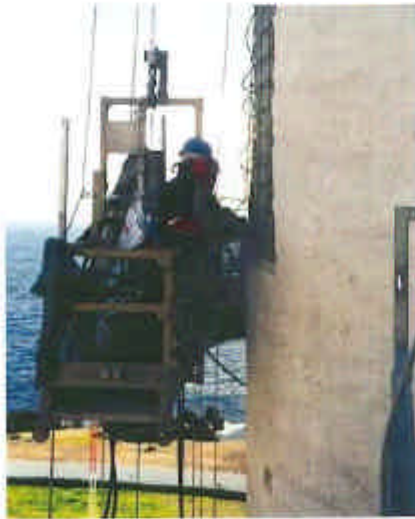
Figure 4 – Removal of deteriorated concrete.

- a) Removal of deteriorated concrete by means of light pneumatic hammers (Figure 4), care being taken to avoid formation of thin scales at the repairs' boundaries during the ensuing spraying of repair concrete.
- b) Cleaning of the exposed reinforcement in order to remove all corrosion products (Figure 5).
- c) Dry-mix shotcreting using double-chamber machines, assuring a concrete cover of 4 cm (1,6 in) minimum (Figure 6).
- d) Spraying of the migrating corrosion inhibitor.
- e) Application, on all external concrete surfaces, of a coat with dry total thickness of 150 micron (6 mils) using acrylic paint.

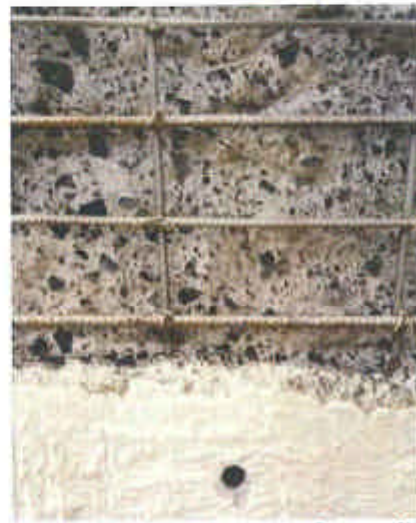
Figure 5 – Concrete surface after preparation, ready for concrete spraying.

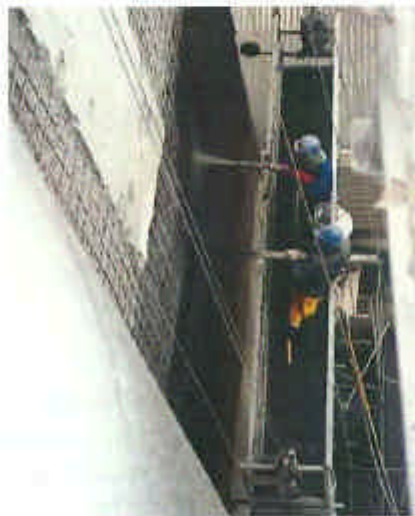
Figure 6 – Concrete spraying.

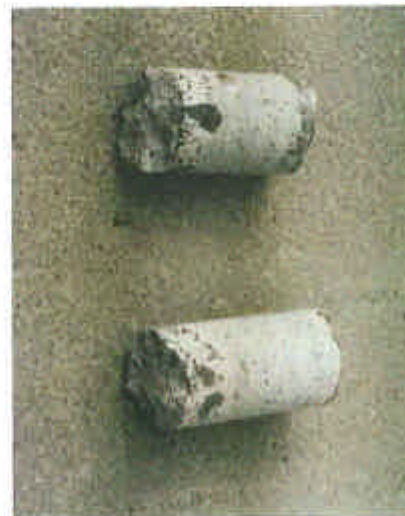
Figure 7 – Small diameter cores after pull-off test (failure through old concrete).

A quality plan was implemented during the silo repair work, including control of supplies and repair processes, inspection and testing over the course of the works and on the final product (Figure 7), as well as accurate recording of relevant evidence on the controls carried out.

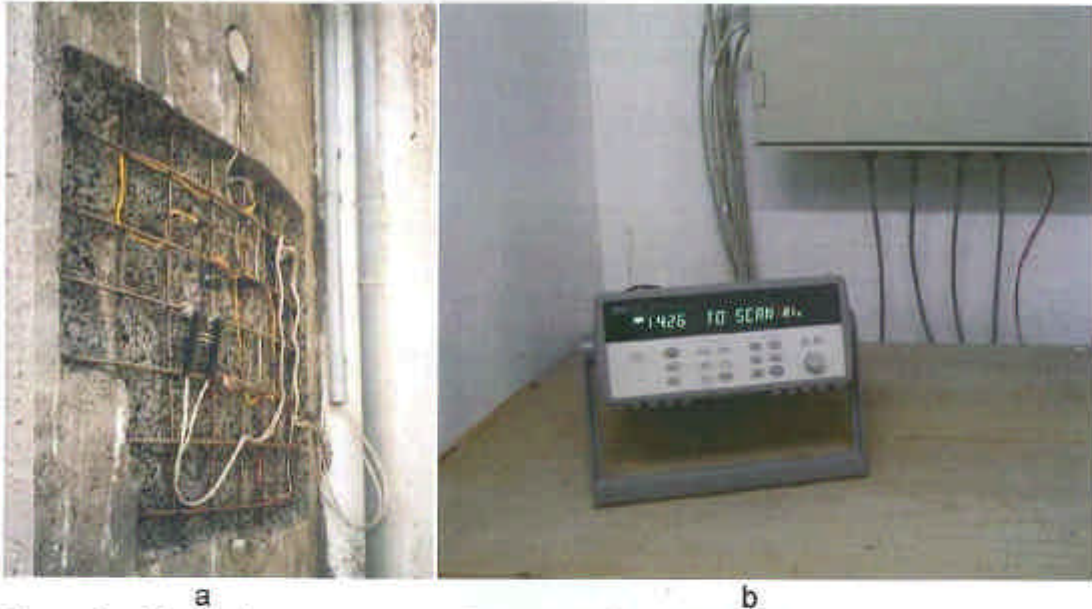
On the repaired surfaces, four areas of 1 m² (10.8 sqft) each were chosen (Figure 8a). Close to each monitored area a sensor was placed in the original non repaired concrete (top of Figure 8a).

Two different macrocell current sensors were built and installed in the original (non repaired) concrete and in the sprayed concrete. Sensors for electrochemical resistance and temperature measurements were also emdedded in the sprayed concrete in each monitoring area. All acquired data are channeled to a central datalogger (Figure 8b).

Figure 8 - Monitoring system: a – Sensors to be embedded in the new concrete and inserted in the existing concrete (top); b – Data logging central.

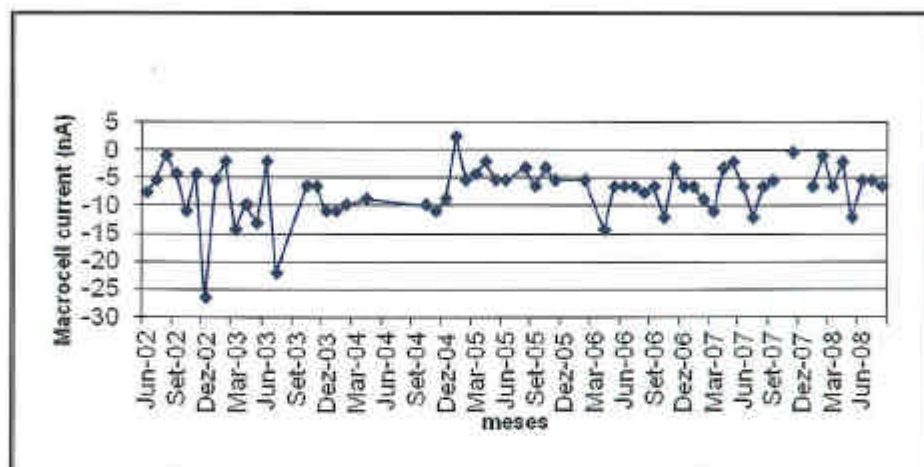
Figure 9 – Macrocell current at sensor 1 (repaired area).

The values of the potential obtained in the repaired areas were initially very negative. However, after two years they were shifting to less negative values, a trend compatible with the repassivation of the rebars. In these areas, the macrocell current values obtained during the eight years up to 2008 have been very low, indicating low corrosion activity. The agreement between the values of the macrocell current with the values of the potential measurements, indicates that the reinforcing steel has been maintained in the passive state and therefore free of corrosion. This demonstrates the effectiveness of the repair method, for the monitoring period.

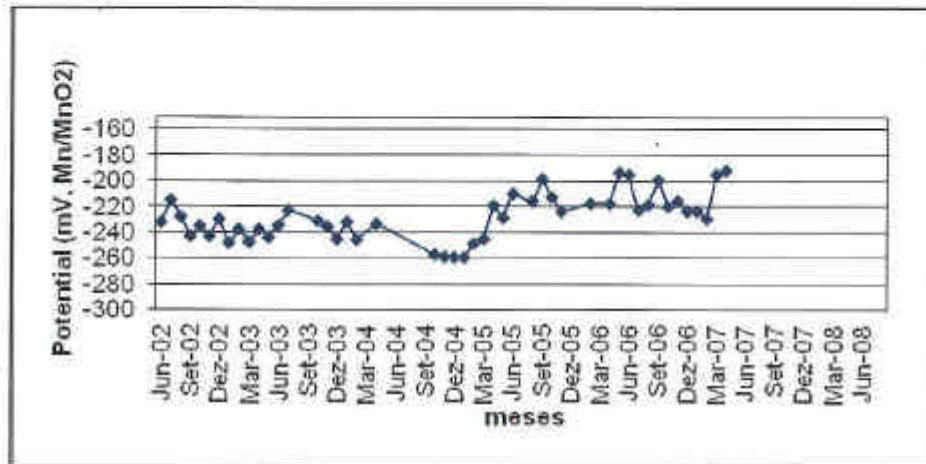
Figure 10 - Potential at sensor 1 (repaired area).

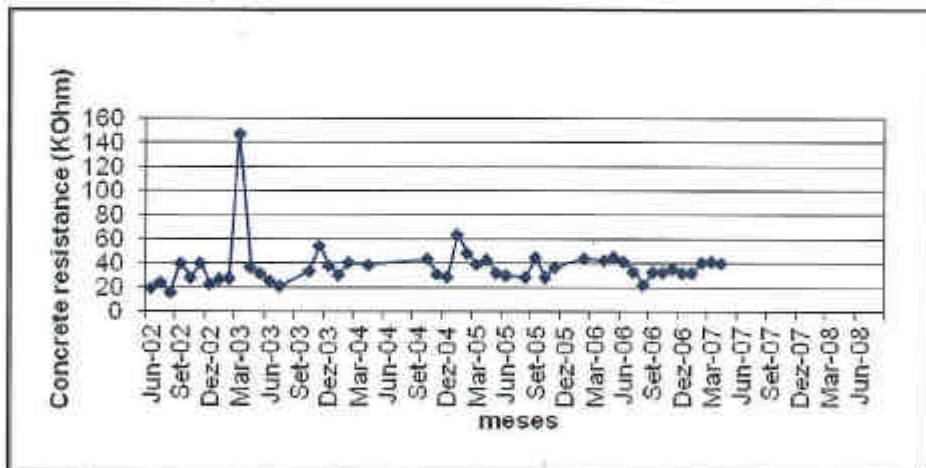
Figure 11 - Concrete resistance at sensor 1 (repaired area).

The concrete electrical resistance values show generally a pattern compatible with the seasonal variation of temperature and rain fall. No trend towards lower values was observed over time.

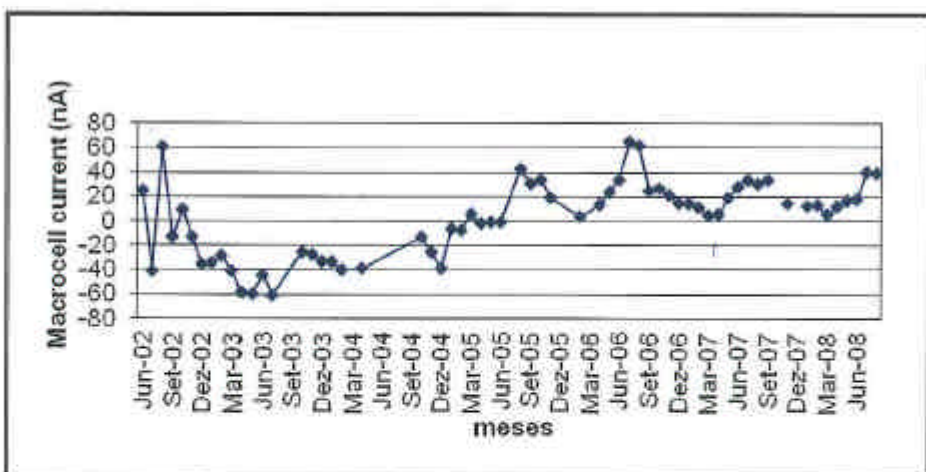
Figure 12 - Macrocell current in one corrosion sensor 2 (non repaired area).

In the areas where the concrete was not replaced, the values of macrocell current obtained initially were also high, indicating some corrosion activity. Again, the values decreased with time to levels of the same order of magnitude of those measured in the repaired areas. This indicates a reduction of the corrosion activity and its absence since the rehabilitation works, in spite of the concrete still being contaminated with chlorides.

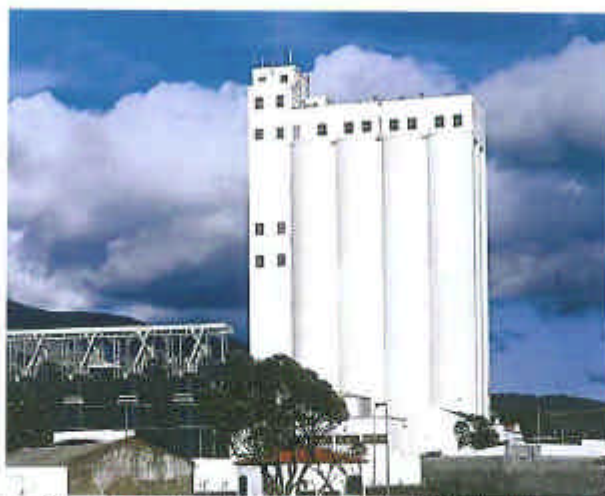
The rehabilitation of the Lagoa silo (Figure 13) presented various challenges: design and construction deficiencies, budget limitations, operational constraints and adverse jobsite environment. The success of the intervention is to be credited to the excellent partnership developed between Owner, Designer and Contractor. This enabled a strict compliance with the appropriate methodology of structural concrete rehabilitation throughout the intervention and beyond. The project is now nearing the term of its ten year warranty. However, monitoring will continue to enable timely maintenance and to make sure that the silo goes on fulfilling its role in satisfactory safety and operational conditions.

Figure 13 – Recent view of the rehabilitated Lagoa silo.
