# **PROTECT 2013**

## Performance, Protection & Strengthening of Structures Under Extreme Loading

## **Strengthening of RC columns with corroded reinforcement by means of high performance jacket**

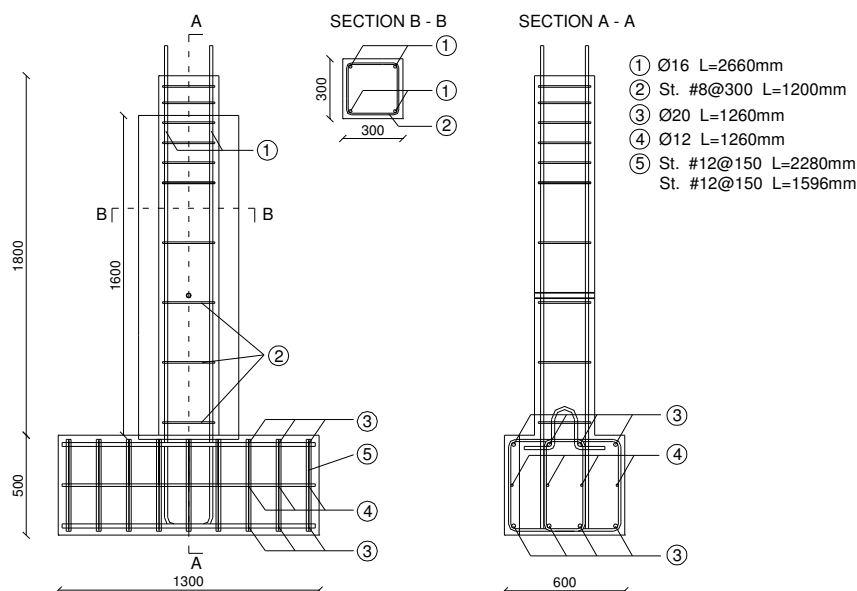
The effectiveness of this new technique, based on the HPFRC jacket application, was studied through three full-scale columns having a height of 1.8 m and a square section of 300x300 mm. The elements have been cast on a 500 mm thick foundation as shown in Figure 1. The reinforcement and the concrete strength of the columns are typical of structures built in the 60's

and 70's. The specimens have been reinforced with 4Ø16mm diameter longitudinal rebars and 8mm stirrups spaced at 300mm. The columns were cast with a low strength concrete: the average compressive strength, measured on 150 mm side cubes, is equal to 20 MPa. The steel reinforcement can be classified as B500C, as the rebars exhibited an average yield strength equal to 520 MPa and an average maximum strength equal to 620 MPa.

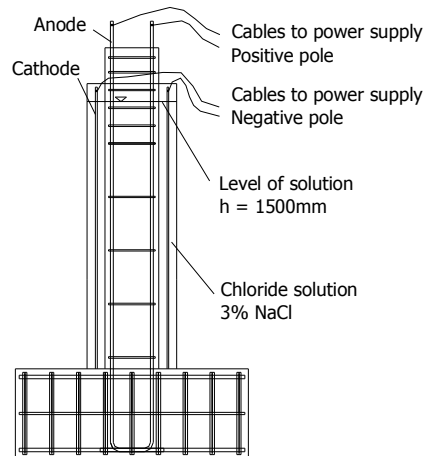
Figure 2. Electrolytic cell used for artificial corrosion process

The artificial corrosion of the reinforcement rebars has been carried out through the use of electrolytic cells (Figure 2). The concrete specimens were partially immersed in 3% chloride solution so that the upper end of the specimens was above the solution. The corrosion of the reinforcements steel was accelerated by impressing a constant current value of 0.5 A.

Each reinforcing bar has been connected to a single power supply in order to achieve a level of corrosion as uniform as possible. The direction of the current was adjusted so that the reinforcing steel of the columns became an anode and four 10 mm diameter bars placed within the chloride solution served as a cathode.

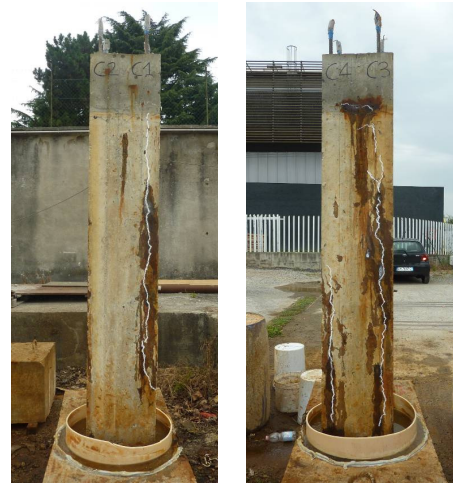
Figure 3. Crack pattern of the columns after the corrosion process

The level of the corrosion is expressed as a percentage loss of mass of the rebars since this parameter is a direct index of the loss strength of the bar. The reinforcement of the columns has been corroded to a theoretical level equal to 20% in terms of mass loss. In order to induce the level of the reinforcement corrosion Faraday's law was used to establish the relationship between the duration of the impressed current and the corresponding degree of reinforcement corrosion. Faraday's law, however, was modified by introducing a corrective coefficient equal to 1.3, (as highlighted by preliminary calibration tests) in order to take into account the volume of concrete around the reinforcing bar. At the end of the corrosion process the production of rust caused the formation of four vertical cracks in correspondence of the corroded bars which extended for the entire height of the columns as shown in Figure 3.

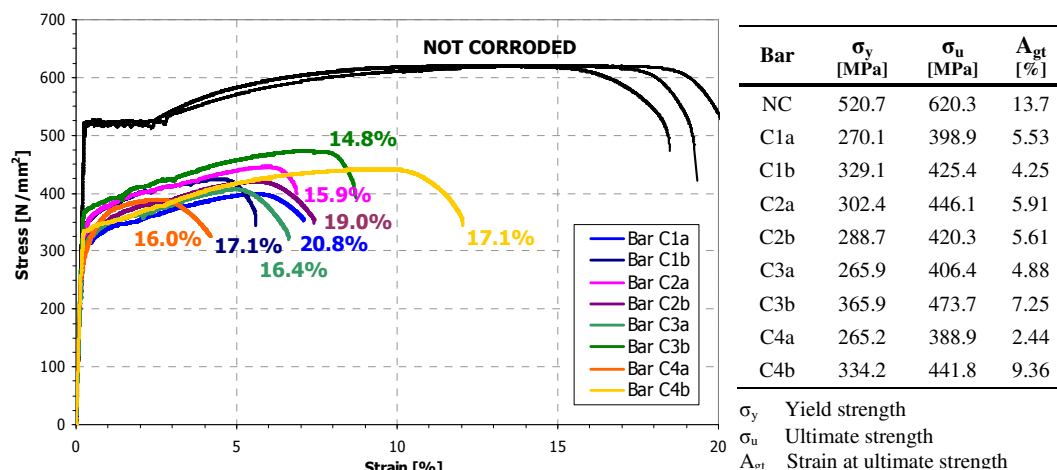
Figure 4. Stress-strain curve and main values from tensile tests of bars

In order to evaluate the mechanical properties of the corroded bars a preliminary test on a column with the same section and reinforcement of the columns to be tested was prepared. At the end of the corrosion process the reinforcing bars have been extracted from the column, cleaned and weighed to verify the effective loss of mass. The bars corroded inside the concrete show a localized corrosive attack and the loss of weight is not homogeneously distributed along the rebars (Figure 5). Each of the four bar extracted has been divided into two segments of length equal to 60 cm, which were subjected to tensile test. The stress-strain curves for non-corroded and corroded rebars are plotted in Figure 4. The nominal stress for the corroded bars indicates the relationship between the measured force and the nominal area of the undamaged, i.e not corroded, specimen. The obtained results clearly highlight that the corrosion attack significantly reduces both the strength and the deformation of the bars.

The reduction of the yield strength and of the ultimate strength is directly proportional to the increase of the level of corrosion of the rebars. For the evident phenomena of pitting, the reduction of ductility is less regular and not strictly dependent of the level of corrosion. The bars corroded inside the concrete show a brittle behaviour.

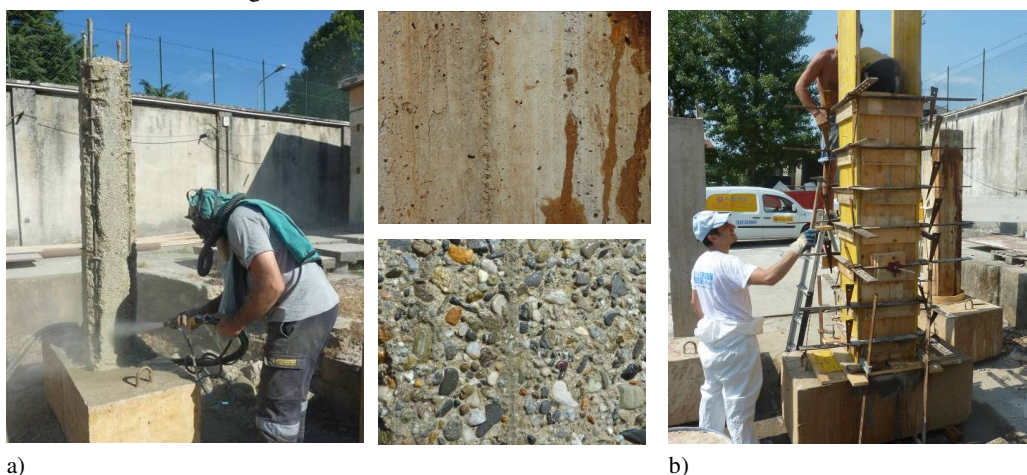
Figure 6. a) Sandblasting of the column and surfaces before and after the treatment; b) Cast of the high performance jacket.

Before the casting of the jacket, the deteriorated cover in correspondence of the four longitudinal bars has been removed and the reinforcements were manually cleaned to remove the corrosion products. In order to connect the jacket to the column base, a pocket 80 mm deep was realized in the foundation. The pocket allows the anchoring of the fiber reinforced concrete to the reinforcing bars in the foundation by providing a joint at the base of the column. The specimen were then sandblasted in order to obtain a roughness of about 1 mm, so as to ensure perfect bond between the existing concrete and the applied high performance concrete. This technique has been demonstrated effective in previous research (Martinola et al. 2010). Figure 6 shows the sandblasting of the column and, in detail, the difference of the surfaces before and after the treatment. The HPFRC material was prepared in a vertical axis mixers and was cast in moulds without vibration. Since curing was carried out at ambient temperature and humidity, a plastic sheet was placed on the upper surfaces in order to limit water evaporation.

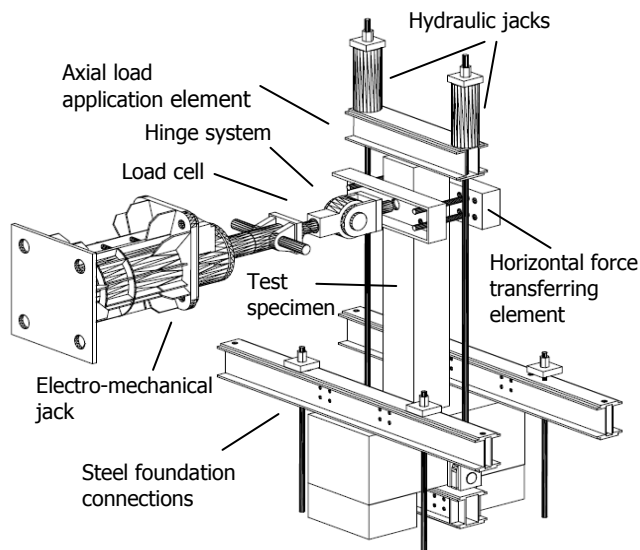
Figure 7. Test set-up

For each specimen, the foundation of the column was anchored to the laboratory basement with two steel profiles and four pre-tensioned high strength rebars. The axial load was applied with two hydraulic jacks and monitored by a pressure transducer. To ensure that the axial load was centred with respect to the column, a self-balanced system was used for the load application. Such system was made of two steel profiles, one placed on the upper head of the column and one in contact with the lower face of the foundation, connected with two high strength rebars, pinned to the lower crossbeam and fixed at the top. The horizontal cyclic load was applied by means of an electro-mechanical jack fixed to the reaction wall of the laboratory. The jack was linked to the column by means of a hinged bar system in which a load cell was placed. The horizontal force was applied at a height of 1.5 m from the column foundation connection. Test set-up is shown in Figure 7.

The tests were done applying to the specimens an axial load equal to 400 kN and then cyclic loads of increasing amplitude.

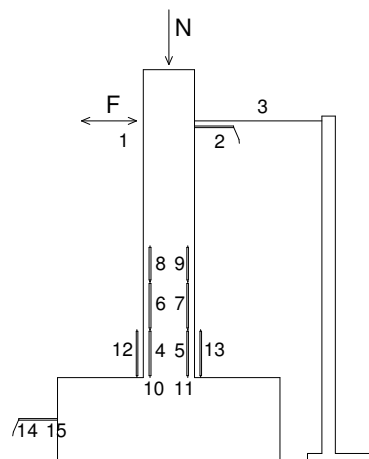
Figure 8. Instrument device

In order to measure the horizontal displacements, potentiometric transducers were placed on the column at the level of the load application, at a height equal to 1.5 m from the column-foundation interface (instruments 2-3 in Figure 8). The rotations at the column base were measured by means of a series of potentiometric transducers placed on one of the column face: the devices 10-11 of Figure 8 were placed in order to measure relative displacements between the column and the foundation base, whereas the devices 4-5-6-7-8-9 of Figure 8 were placed on the column to measure relative displacements between points of the column itself. To measure possible slip movements of the bench, two LVDT devices were adopted (14-15 in Figure 8). A pressure transducer was connected to the pump for the axial load monitoring.

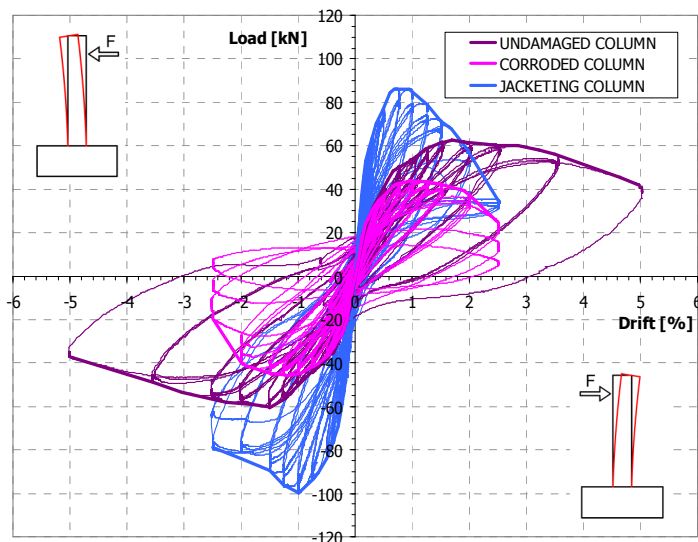
Figure 9. Horizontal load versus horizontal displacement curves for the three specimens tested

The results in terms of horizontal load versus displacement at the level of the load application point are shown for all the specimens in Figure 9.

CNC	CC	CJ
$M_{\max+}$ [kNm]	92.6	65.0	130.0
$M/M_{\text{CNC}}$	1.00	0.70	1.40
$M_{\max-}$ [kNm]	89.1	67.3	147.1
$M/M_{\text{CNC}}$	1.00	0.76	1.65
$\delta_{\max+}$ [%]	2.00	1.00	0.75
$\delta_{\max-}$ [%]	1.50	1.25	1.00
$\delta_{u+}$ [%]	5.00	2.50	2.00
$\delta_{u-}$ [%]	5.00	2.50	2.50

CNC Undamaged column  
CC Corroded column  
CJ Jacketing column

The specimen not corroded (CNC) reached its maximum strength, equal to 63 kN for the horizontal load and 92.6 kNm for the moment, at a drift equal to  $\pm 2\%$ . In the following cycles a progressive strength degradation was observed, up to a value of about 50 kN, at a drift of 5%, equal to the 80% of the column strength. The test were stopped after the execution of the first cycle corresponding to a drift of 5%, after which cover spalling and concrete crushing occurred at the column base for a height approximately equal to the section side. It was observed, moreover, the deformation of one of the reinforcing bars due to buckling.

The maximum load measured for the corroded columns (CC) was about 46 kN, corresponding to a moment of 67 kNm, reached at a drift equal to 1.25%. The strength in correspondence of the final cycle, that occurred at a drift of 2.5% is of 36 kN, i.e. approximately 78% of the maximum load reached. From cycles ranging from a drift of 0.25% to 1.00% the specimen shows horizontal cracks which grow in number and extension and are placed in an area of height of about 70 cm from the base of the foundation. From the cycle corresponding to a drift of 1% the vertical cracks due to corrosion, visibly open. From a drift of 2% cover spalling occurred. The test was interrupted in correspondence of a drift of 2.5% after the complete crushing of the concrete. It is clearly noted the buckling phenomenon occurring in all the reinforcement bars.

The maximum load for the jacketing column (CJ) for positive cycles was about 86 kN for the horizontal load and 127 kNm for the moment, reached at the 0.75% drift cycle, while for negative cycles the maximum strength was about 100 kN for the load and 147 kNm for the moment in correspondence at a drift of 1%. The appearance of the first crack due to the bending in the jacket occurred at a drift of 0.30%. The cracks, that affect an area of about 60 cm height of the level of foundation, developed with a spacing of about 300 mm, equal to the stirrup spacing. From a drift of 0.75% the flexural crack in the external jacket was stable (Figure 12) while a local damage of the HPFRC jacket was occurred at the interface column-foundation (Figure 13). In the case of positive drift damage is not localized exclusively to the interface column-foundation, but there was a gradual hoist of the fiber reinforced jacket by the base foundation. This phenomenon, that not corresponds to the real behaviour of the column, has caused a significant loss of strength in the case of positive drift. The progressive pinching of the cycles for drift values higher than 1.5% is related to the detachment of the HPFRC layer at the base, whereby the contribution of the tensile

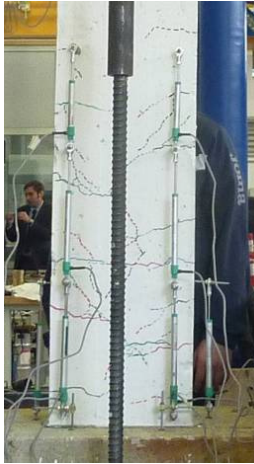
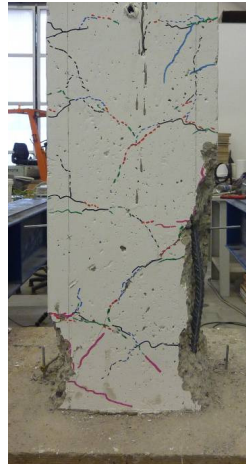
Figure 10. Specimen CNC at a drift of 2% and at the end of the test

Figure 10 and Figure 11 show the crack pattern of the specimen not corroded and corroded for a drift of 2% and at the end of the tests.

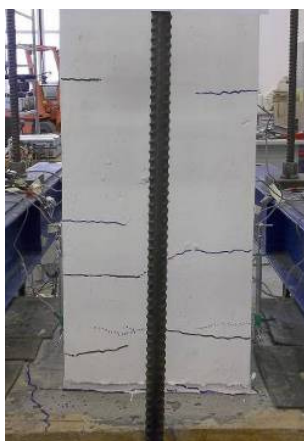
Figure 12. Specimen CJ at drift of 0.75% and 2%

strength of the jacket layer at the base is progressively lost, and a rocking mechanism takes place at the column base. The column has reached the collapse during the third cycle corresponding to a drift of 2%, due to the rupture of one of the longitudinal rebars for positive drift. In order to deepen the knowledge of the specimen behaviour, as for the negative drift load was still high, it was decided to perform even the cycles of 2.5% drift. The test is terminated at the second cycles equal to a drift of 2.5% at the breaking of the second reinforcing bar. At the time of the collapse load was equal to 82 kN, corresponding to 82% of the maximum stress reached for positive displacement values.

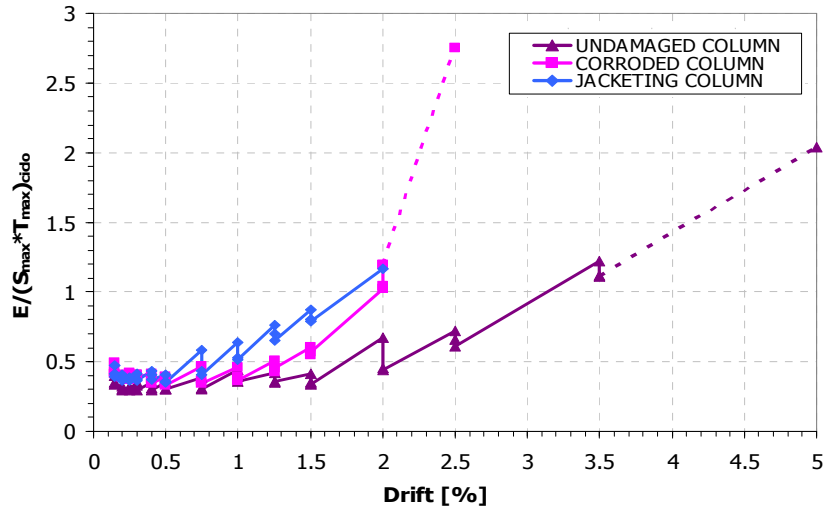
Figure 14. Comparison between dimensionless dissipated energy

The comparison between not corroded specimen (CNC) and corroded column (CC) shows the effectiveness of the methodology of the accelerated corrosion of reinforcing bars. The corroded column has both a decrease in the maximum strength (the maximum load is about 73% of the load achieved by the undamaged specimen) and a marked decrease of deformation since the not corroded column reached the collapse for a drift of 5%, while the maximum drift for the corroded element is only 2.5%. The results obtained from the jacketing specimen showed the efficacy of this technique for strengthening columns with corroded longitudinal rebars. The maximum load for both positive and negative stress is higher than the peak load reached by the undamaged specimen. Observing the values obtained for negative drifts, the direction in which the strengthening specimen showed a correct mode of failure, the maximum load of the column shows an increase of 65% compared to that of the undamaged column and an increase of 118% in comparison to the peak load of the column with corroded reinforcement. The shape of the envelope curve is typical of the behavior of a section characterized by a RC core with a HPFRC jacket. After reached the maximum load the strength of the specimen suddenly decayed because the tensile contribution of the HPFRC gradually disappeared due to the opening of a macro-crack between the column and the foundation. In the cycles after the peak load (for negative drifts) the load was however higher than that of the unreinforced specimen for the compression contribution of the HPFRC jacket. The specimen with HPFRC jacket has not shown crushing of the concrete cover or deformation of the longitudinal rebars due to the confinement action carried out by the layer of high performance concrete. A comparison between the experimental results of the three specimens can be performed in terms of dimensionless dissipated energy, as shown in Figure 14. The specimen with fiber reinforced jacket shows a better behavior in terms of energy dissipation. For cycles at high drift (0.75% - 1.00%) the HPFRC jacketing specimen with corroded longitudinal rebars dissipated 30%

more energy than specimen with corroded rebars and no jacketing and 50% more energy compared to the undamaged specimen. The energy dissipated for undamaged and corroded columns in the final cycles (dashed lines) results to be high due to the complete expulsion of the concrete cover and buckling of the longitudinal reinforcements (see Figures 10-11-12). It is observed that the dissipated energy for the strengthening columns during the cycles triplets is stable, proving the validity of the proposed rehabilitation method.

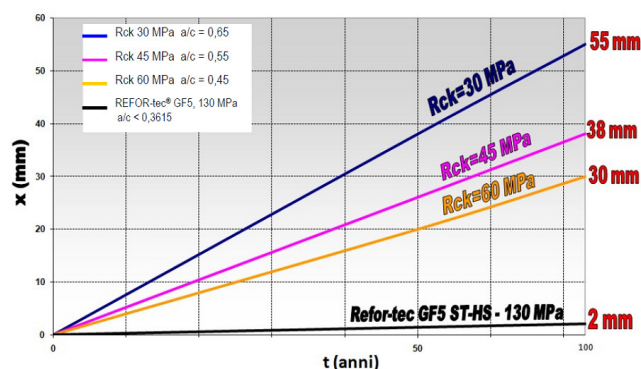
Figure 15. Penetration of CO<sub>2</sub> for normal concretes and for HPFRC used in this research

The three full-scale tests presented demonstrated the effectiveness of the HPFRC jacketing technique for columns with problems of corrosion of longitudinal rebars. With the application of a high performance jacket it was possible to increase the bearing capacity of the column with corroded rebars reaching a maximum strength greater than that of the corresponding not damaged element. This technique resulted suitable for strengthening existing RC structure characterized by low concrete strength, low reinforcement ratio, concrete damage and corrosion of rebars. The use of the high performance concrete layer can protect the internal column, by increasing its durability, as shown in Figure 15 where it is reported the difference in the penetration of CO<sub>2</sub> for a normal concrete and for the HPFRC used in this research. The proposed technique can be easily used in structural application as it allows strengthening R/C elements by means of a thin jacket: a curing at ambient temperature and humidity is sufficient to allow the development of the strength characteristics and a simple sandblasting ensures a good bond between substrate and HPFRC.
